Walk Around

Fw 190D

By E. Brown Ryle and Malcolm Laing

Focke-Wulf Fw 190D-9

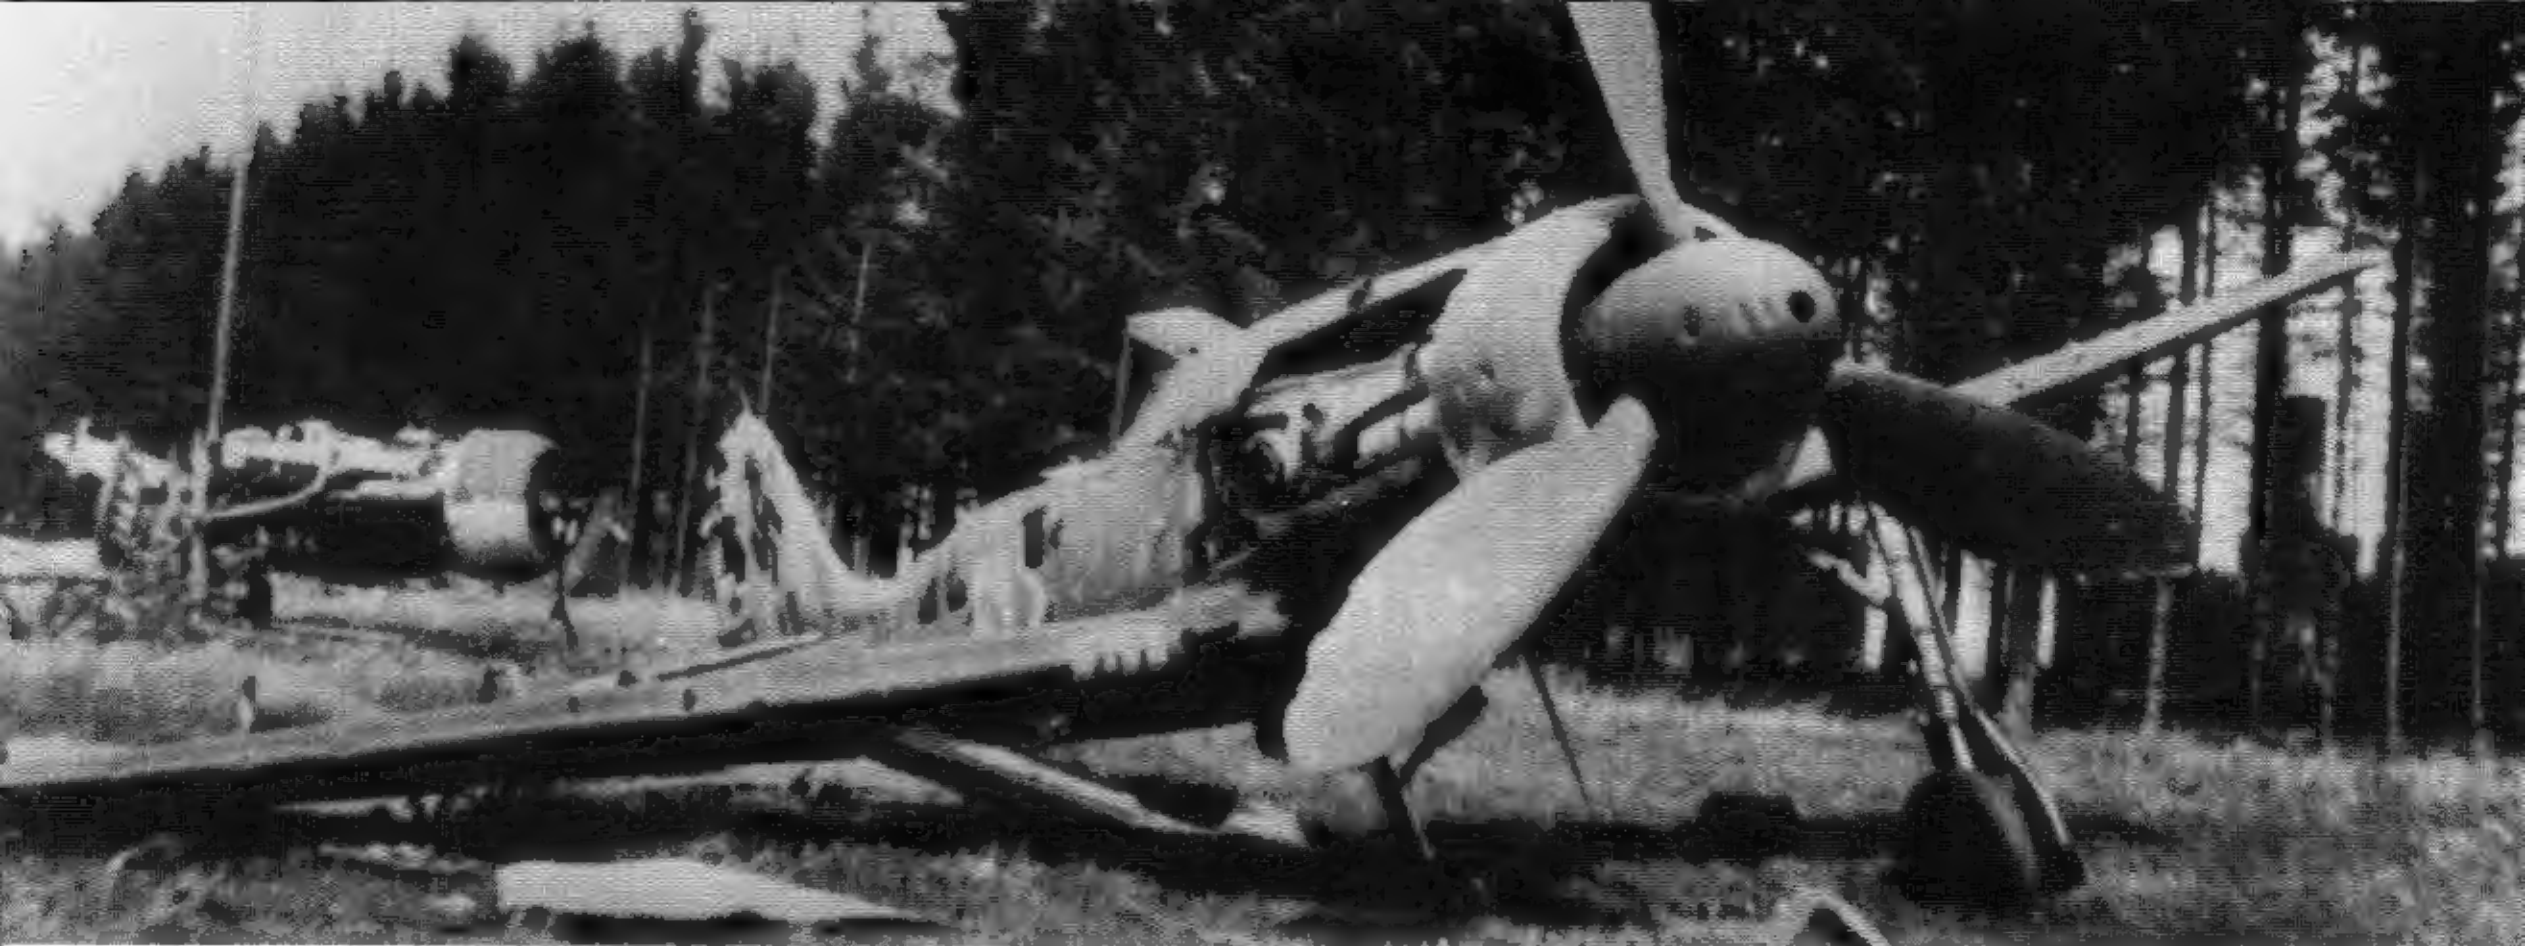
White <61, (W.Nr.350158, but possibly W.Nr. 220004) an Fw 190D-11 at Bad Worishofen during the summer of 1945. The aircraft retains its spinner for the engine mounted cannon, but the cannon was not installed, however, the wing's 20mm inboard and 30mm out-

board cannons are clearly seen as are the unusual leading edge aircraft numbers painted just outboard of the 20mm cannons. (Petrick via Wadman)

White <61, an Fw 190D-11 (the Work Number was previously listed as 350158, but is most probably 220004) at Bad Worishofen during the summer of 1945. The spinner and blades are in 70 and has an opening for an engine mounted cannon, but no cannon is installed. Fuselage is 83/75/76 with the fuselage being heavily over sprayed. 81 on tail. The fuse-

lage extension plug is either light 76 or natural metal. The aircraft's number is painted on the leading edge of the wing. Upper wing and stabilizer is 83/75. The Wing's bottom is metal with 76 only on trailing half.

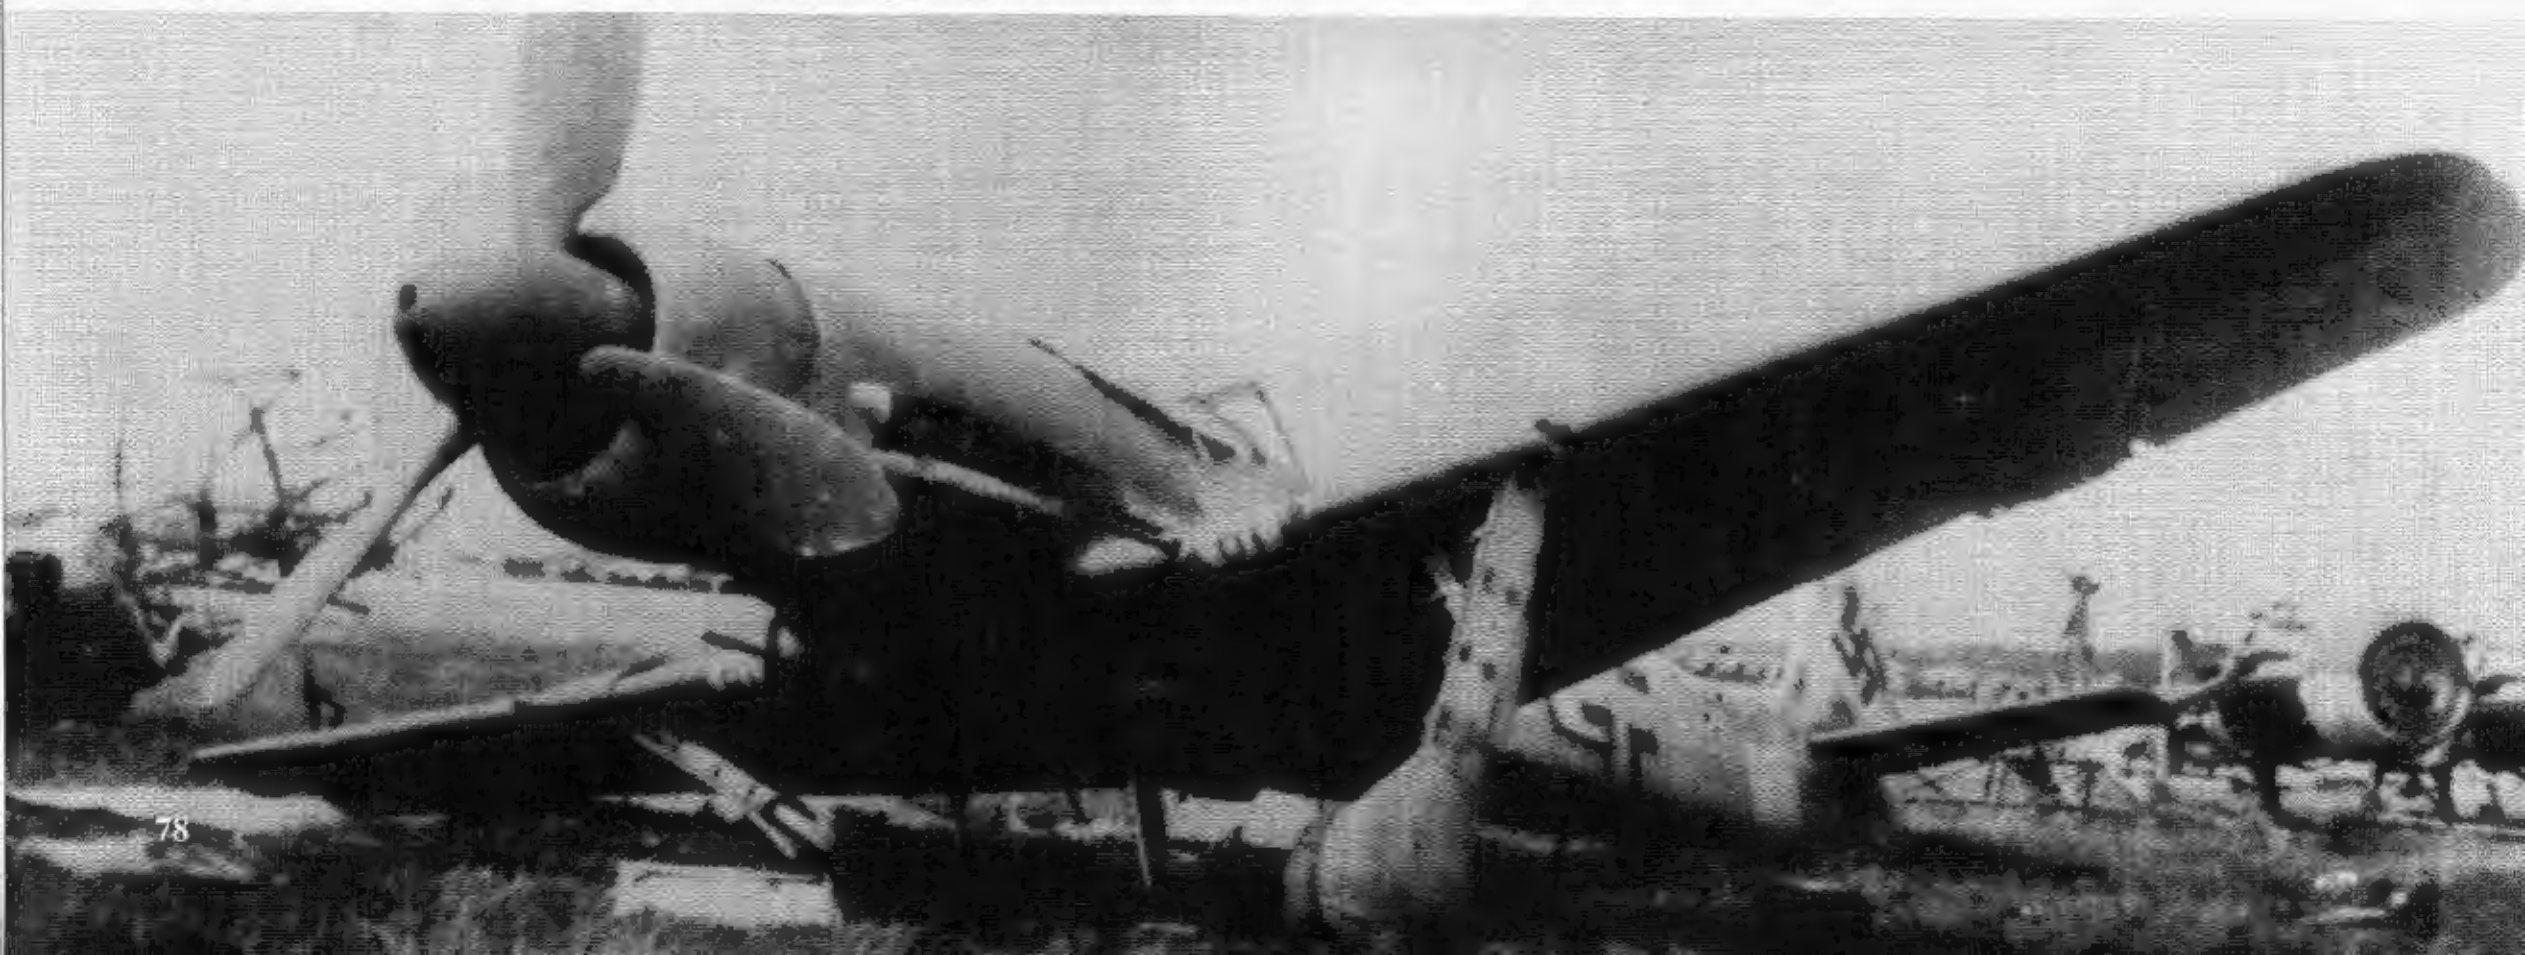
(Above) Red 1, an Fw 190D-9 (W.Nr. 600424), of JV 44's protection flight, the Würger-Staffel or Sachsenberg Schwarm, commonly mis-referenced as the Papagei Staffel. Based at Munchen-Riem in May of 1945, these piston engined aircraft were assigned the task of protecting the Me 262 jets from marauding allied fighters during take-offs and landings. Since the field was also heavily protected by flack batteries these airfield defense fighters had their lower surfaces brightly painted to be quickly recognized as friendly air-

craft by the flack crews. The inscription on the fuselage translates: Sell my clothes I'm going to Heaven. (D. Wadman)

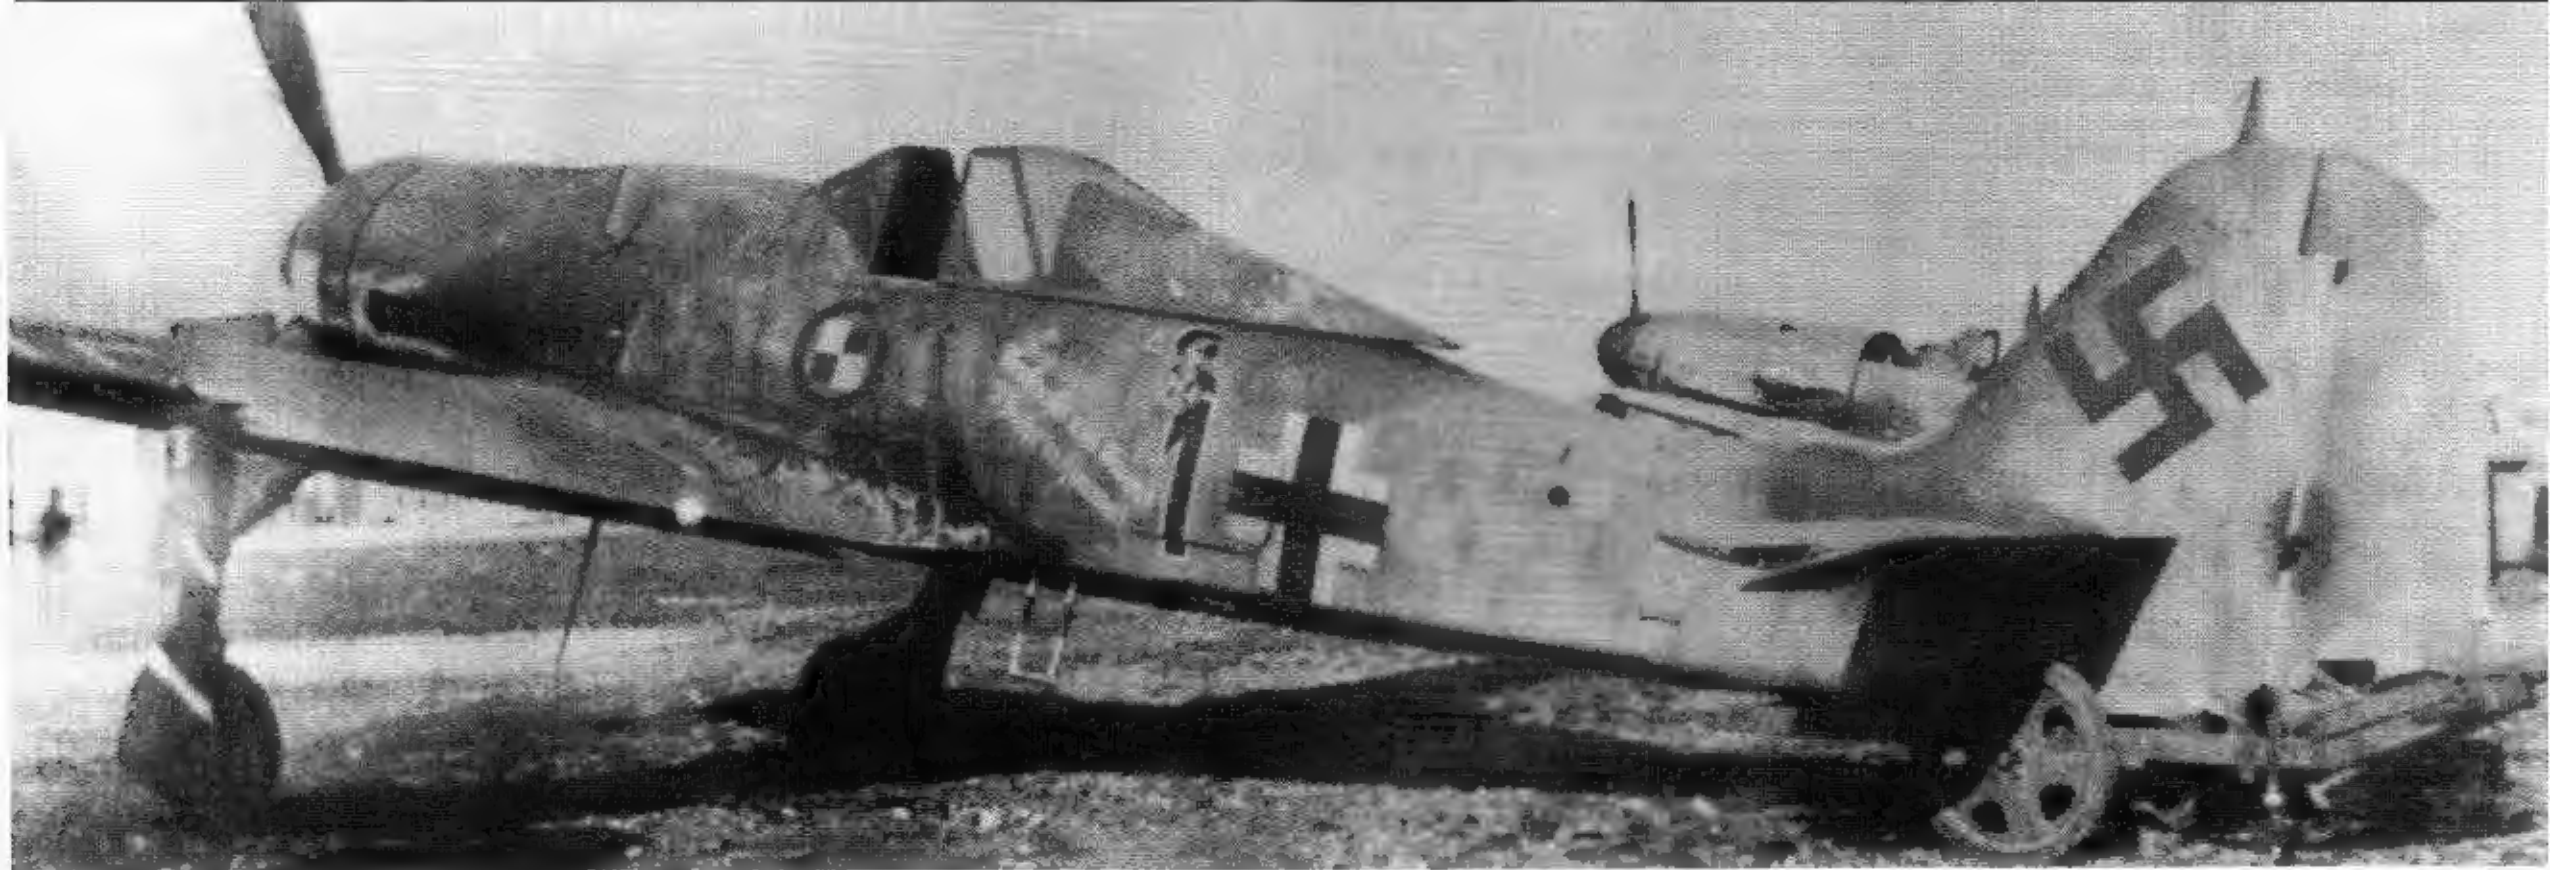
(Below) Red 1 showing the special Red paint and White recognition stripes applied to the aircraft's entire underside. The bottom paint and striping was applied 'in the field' and as such was far from perfect. (D. Wadman)

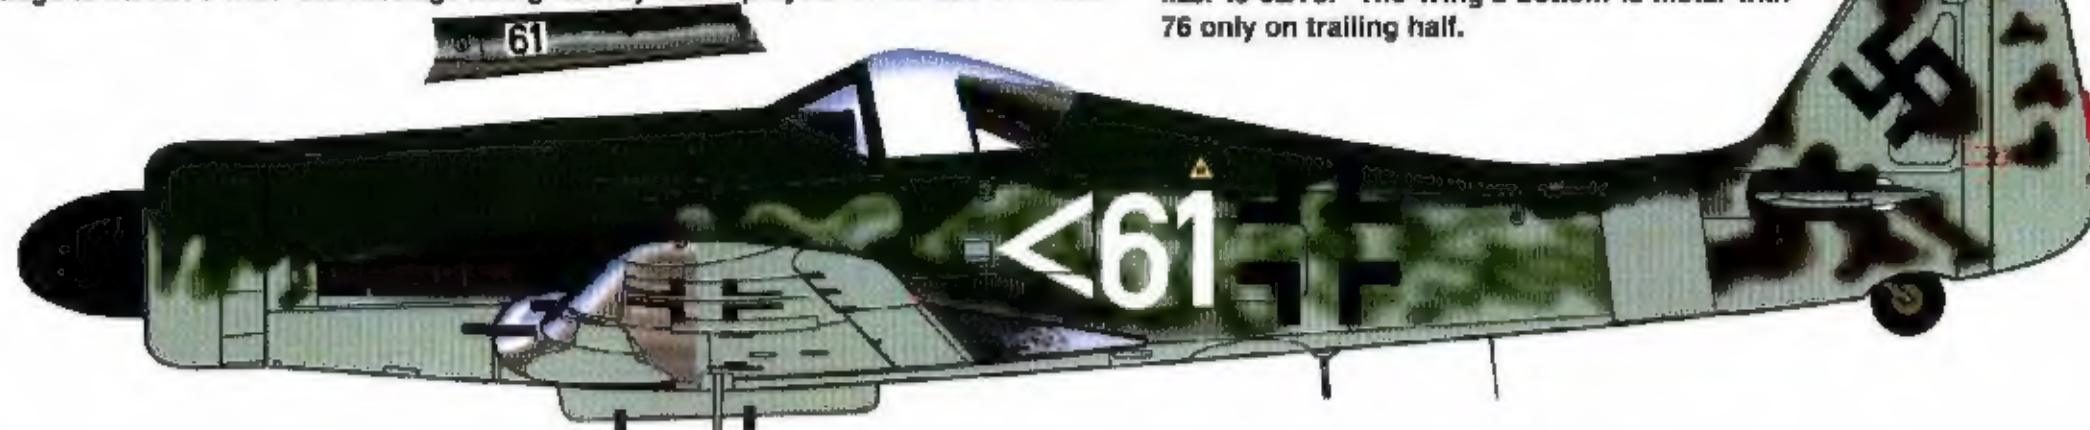
Red One, an Fw 190D-9 (600424) at Munchen-Reim in May of 1945. The aircraft belonged to JV 44's protection flight and is believed to have been flown by Hptm Waldemar Wubke. The spinner front is Yellow and the spinner rear is RLM 70. The fuselage is painted RLM 82/83/76 The fuselage and wing bottom are painted Red with narrow white stripes. The upper wing and stabilizer is painted 82/83. The circle and checker board emblem is the unit crest. The inscription translates as "Sell my clothes I'm going to Heaven".
